Theme: Oxydated fuse

Theme area Electrical Telephone +49 (0)40/ 739 606 – 42

Version 02/2010 Date: 11.02.2010

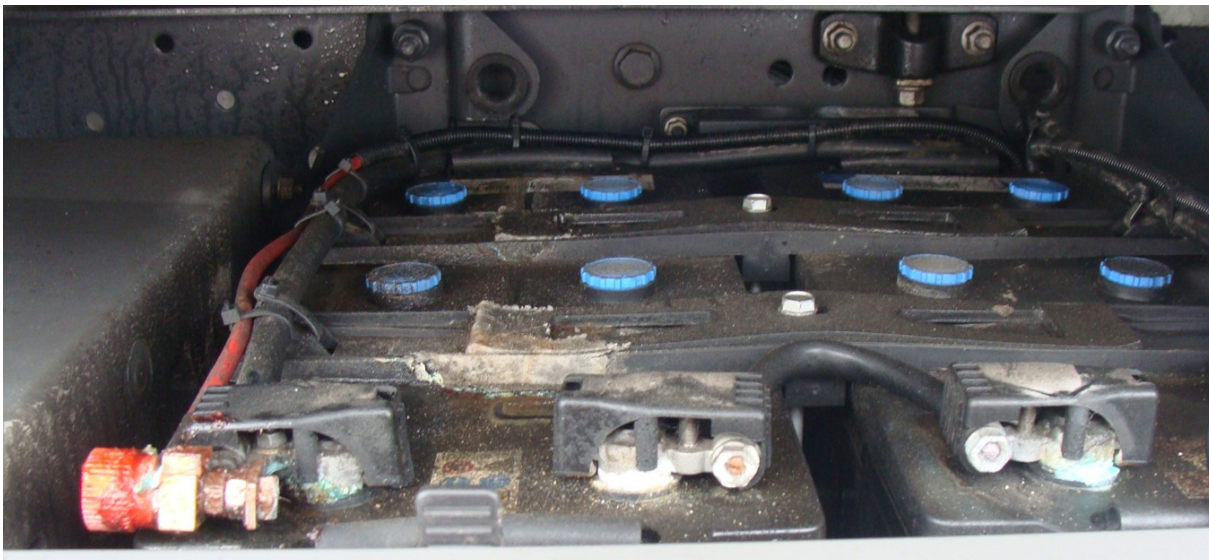
Photo 1

Battery cable / tail-lift fuse is not secured enough against splashing water

In order to avoid failure, we suggest following steps:

Loosen the battery plus clamp, remove the copper bridge
Cut the red cable (16 mm²) about 100 mm behind the cable socket

Remove about 10-15 mm of the cable protection at its end

Squeeze the cable socket open
Screw on the fuse

Position the shrink hose in the middle over the fuse
Shrink the hose with a hot air pistol
Screw the cable socket directly onto the battery clamp
